# Hazard Alert

## HAZARD SUMMARY

**Hazard Location:** *Powered mobile equipment.*

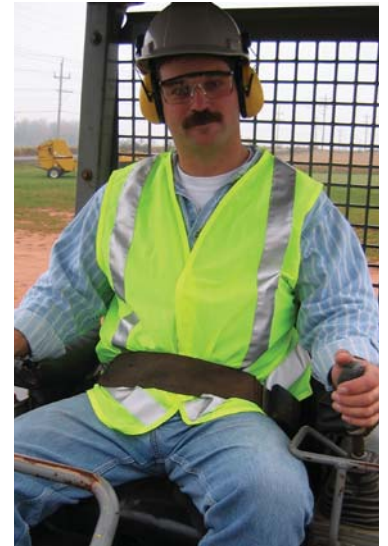
Recently, on Prince Edward Island, a construction worker was seriously injured when the construction equipment the worker was operating rolled over. The worker was not using a seatbelt at the time of the incident.

- The Construction equipment operator was not wearing a seatbelt.
- The worker was injured when thrown outside the safety of the Rollover Protective Structure (ROPS).

- Ensure all powered equipment operators are wearing seatbelts or approved restraining devices at all times while operating construction equipment.
- Ensure seat belts and restraining devices are in proper working order at all times.
- Ensure all Rollover Protective Structures (ROPS) are designed to protect the operator from being crushed in the event of a rollover.
- Ensure operators are properly orientated in the use and limits of the equipment they are operating.
- Ensure all operators have training in what to do in the event of an equipment rollover.
